ENVIRONMENTAL DUE DILIGENCE AUDIT

For the Identification of
Potentially Hazardous Materials and Conditions

Former Air Force Accounting and Finance Center
3800 York Street
Denver, Colorado

November 1994

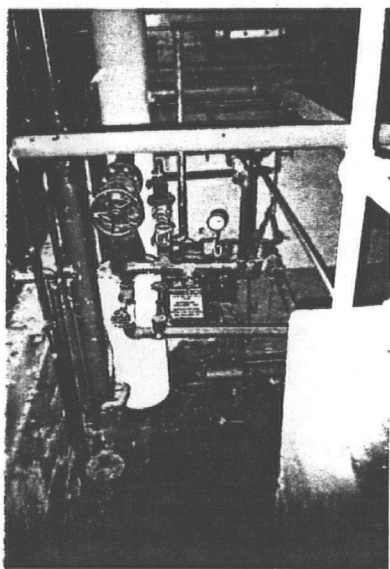
Based on exterior appearance and the portions of the interiors of the buildings which were available for inspection, suspect ACM include the asphalt shingles on the roofs and the white thermal system insulation around many of the pipelines. One pipeline was labelled as containing asbestos in Building 4. Other materials present in the building that are suspect ACM include ceiling tiles, window caulking, and wall board and joint compound. Some of the suspect ACM appeared friable and deteriorated while others appeared intact. A comprehensive survey is required to verify the presence, amount, and type of asbestos and would include the sampling and analysis of these materials.

Building 4: Pipes inside the Steam Power Building which contain suspect asbestos-containing insulation.

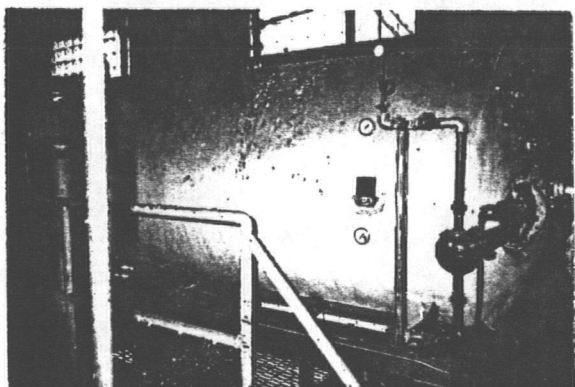
Building 4: Pressurized Water Tank.

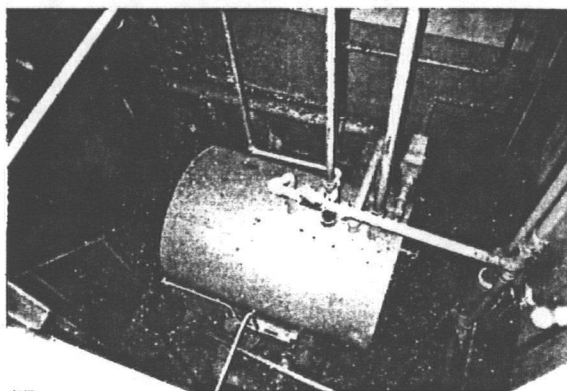
Building 4: Fuel tank inside the Steam Power House.

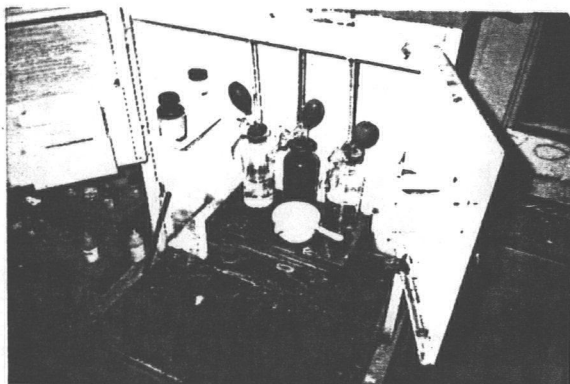
Building 4: Laboratory indicator chemicals inside the Steam Power House.

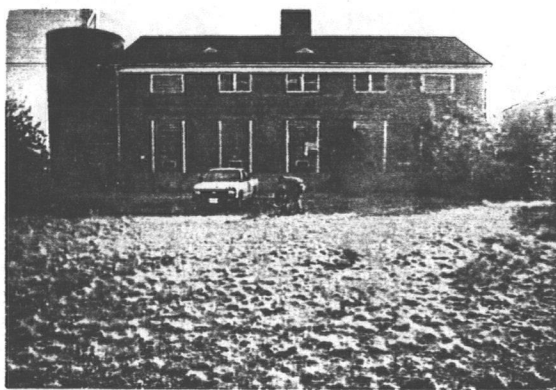
A tank farm containing an unknown number of USTs was identified adjacent to and west of Building 4. No other anomalous topography, surface disturbance, or evidence of burial or imported fill was observed at Building 4.

Lawn west of Building 4: location of underground storage tanks.

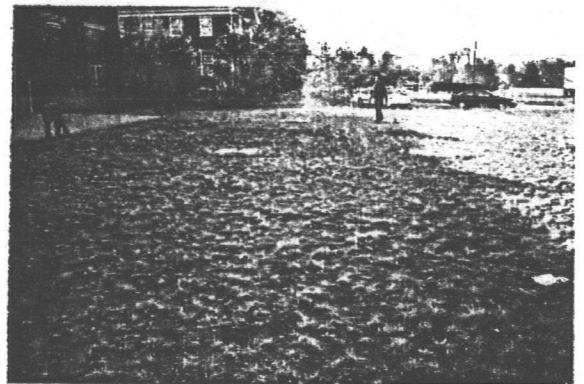
The tank farm area west of Building 4 is covered by an unwatered lawn. The grass was stressed from the lack of water, but no stained soil was observed. All other areas surrounding Building 4 are covered with asphalt and there were no stained areas. A hole in the asphalt was observed east of Building 4 and exposed an underground sewer line.

Vegetation in area of UST tankfarm fill ports west of Building 4.

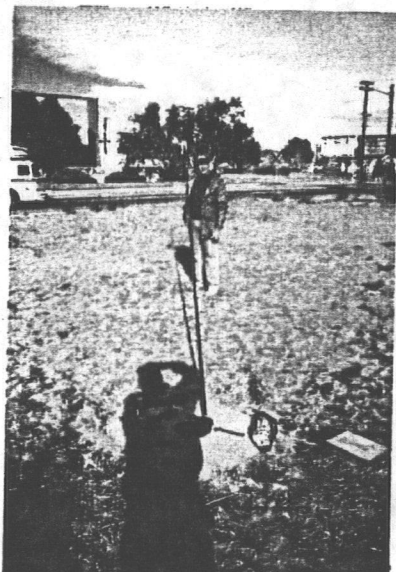
Contents of a UST in tank farm west of Building 4.

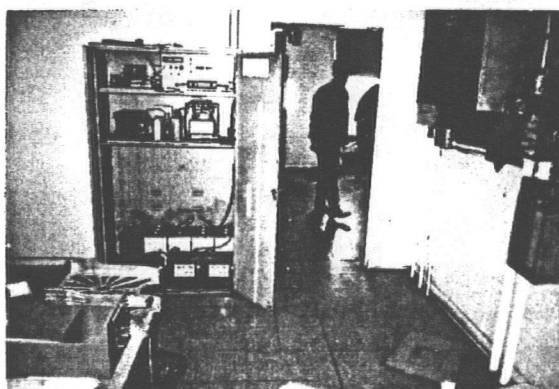
Building 6: Electronics equipment and batteries.

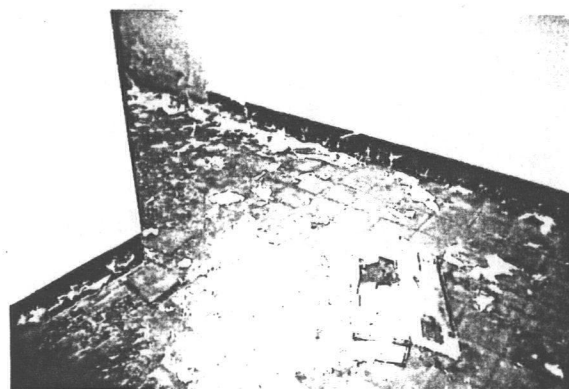
Buildings 6, 7, and 12: Peeling paint typical of potential lead-based paint.

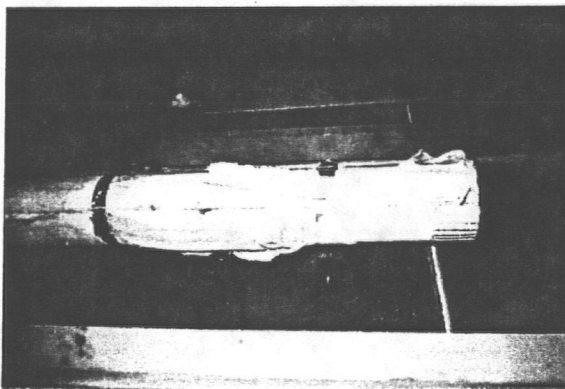
Buildings 6, 7, and 12: Pipe insulation typical of suspect asbestos-containing material.

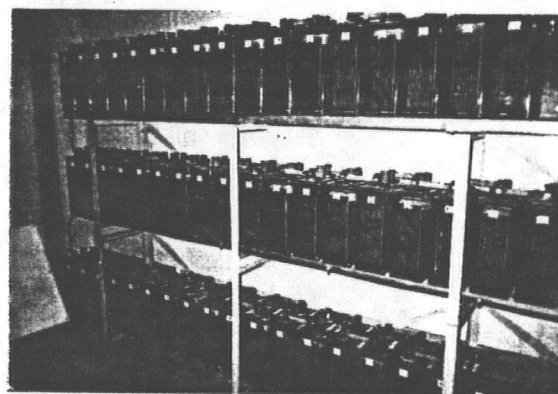
Lead acid batteries in Building 1.

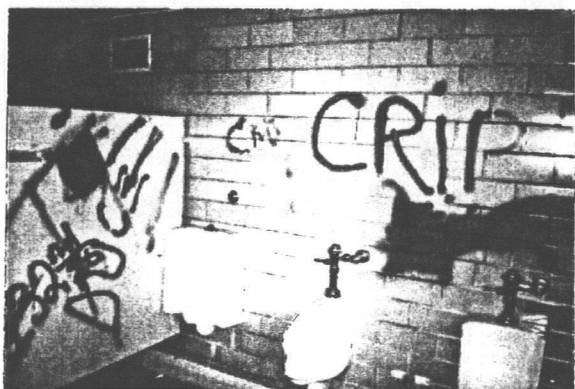
Evidence of gang activity in Building 1.

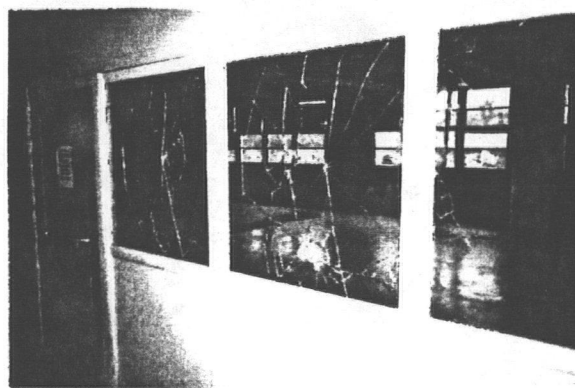
Vandalized conditions typical of rooms in Building 1.

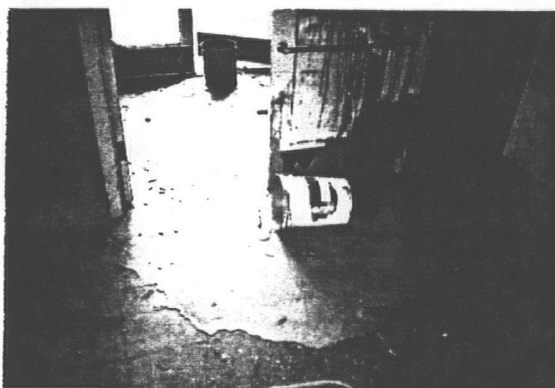
Vandalized conditions typical of halls in Building 1:

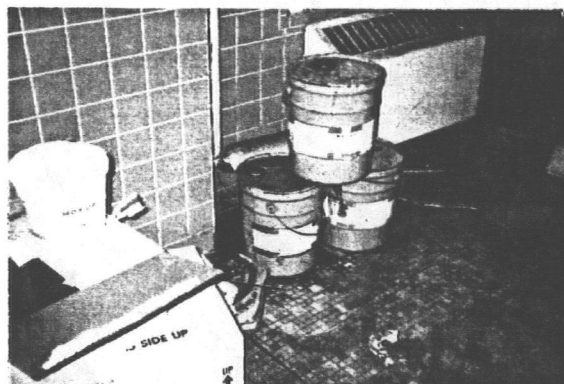
Building 1 Unit F: Containers of insecticide and floor cleaning chemicals in bathroom; note potentially asbestos-containing insulation on pipe leading to steam heat register.

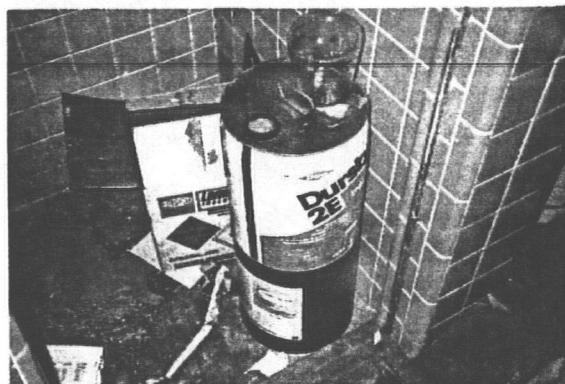
Building 1 Unit F: Containers of insecticide in bathroom.

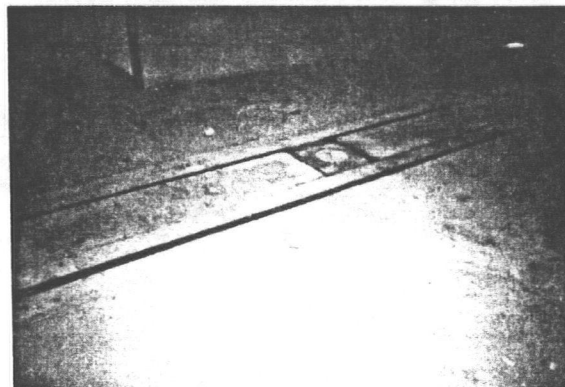
Concrete filled trench and possible oil trap in floor of Building 1 Unit F.

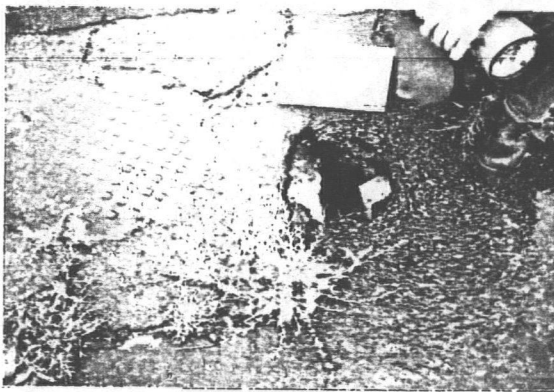
Hole in asphalt parking lot, south of Building 1.

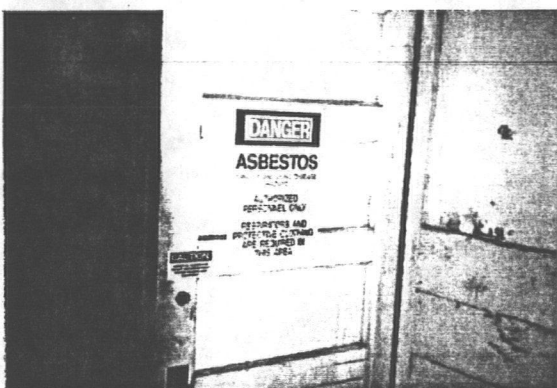
Building 2: Asbestos warning sign for insulation on pipes typical of conditions in Building 1 and Building 2.

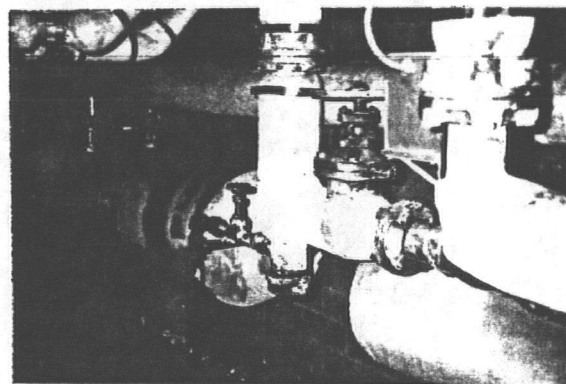
Potentially asbestos-containing pipe insulation in Building 2.

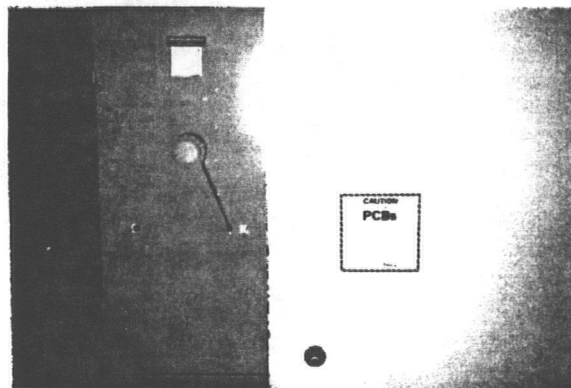
Building 2: Sign identifying PCBs in transformer.

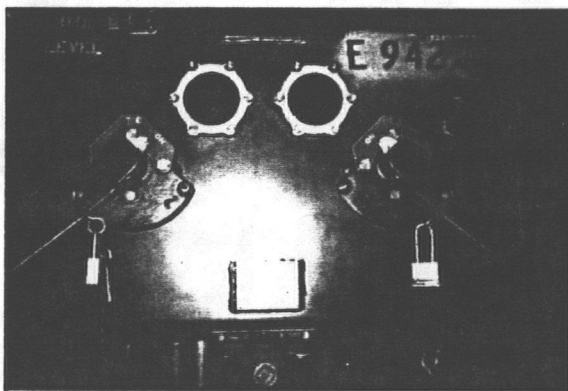
The transformers located in Building 2 were labelled as containing PCBs. The transformers observed were unstained, uncorroded, and appeared to be intact. However, a drip pan containing discolored "saw dust" was observed beneath one of the transformers located in the upstairs mechanical room in Unit L of Building 2. In addition, a 5-gallon can of transformer oil which apparently had leaked was observed nearby. The transformers located in Building 1 were not labelled regarding PCB content. These transformers were located in the building used by the Denver Public Schools and appeared to be newer than the transformers located in Building 2. The transformers located in Building 1 were unstained, uncorroded, and appeared to be intact. No drip pans were beneath the transformers in Building 1. Electrical relays were located outside and adjacent to Buildings 1 and 2. These transformers were also unstained, uncorroded, and appeared to be intact (Appendix F - Site Photographs).

Transformer in Building 2.

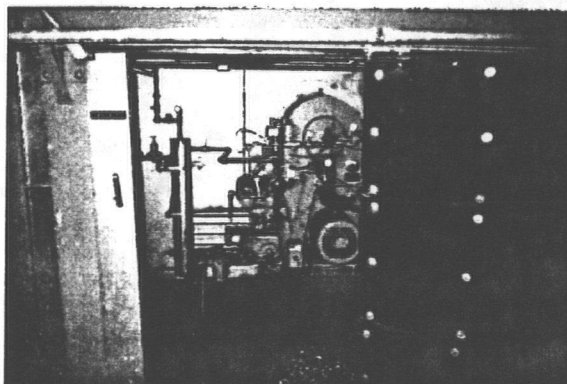
Boiler in Building 2. Note oil stain on concrete floor.

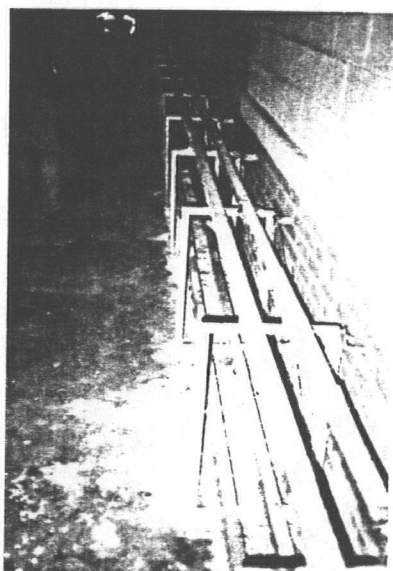
Building 2: Empty racks with battery acid stains in battery room.

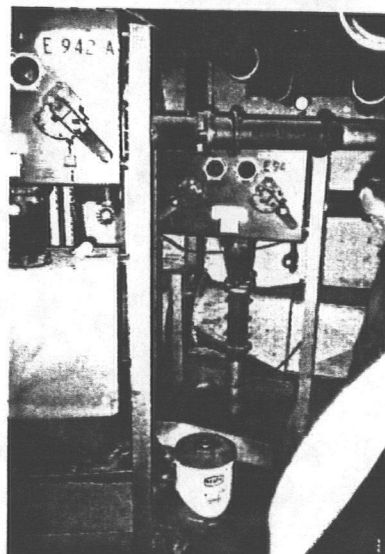
Transformer with drip pans in Building 2. Note 5-gallon container of transformer oil and oil stains on floor.

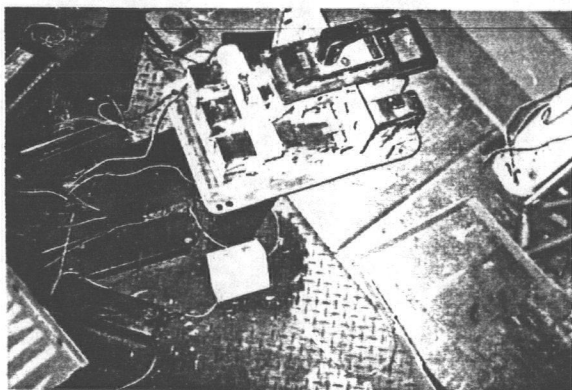
Fluorescent light ballasts in Building 2.

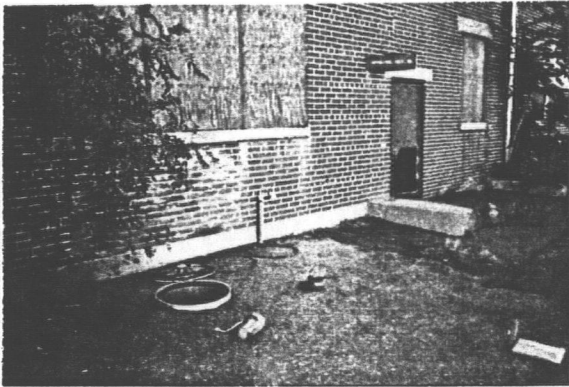
Location of possible UST on west side of Building 8 (Motor Pool building) located east of Building 2.

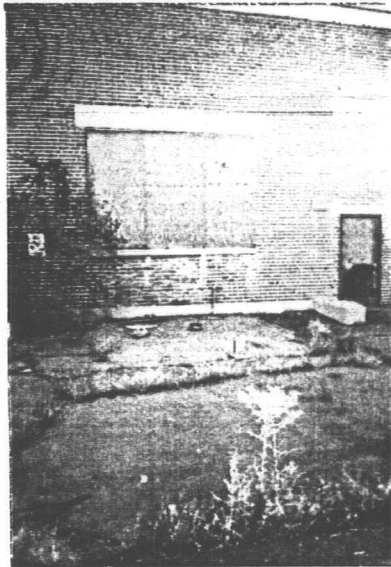
Possible UST or oil trap on west side of Building 8, the Motor Pool building.

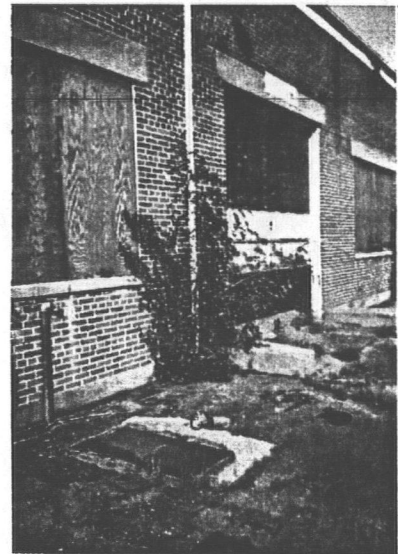
Garage door and oil trap on east side of Building 8.

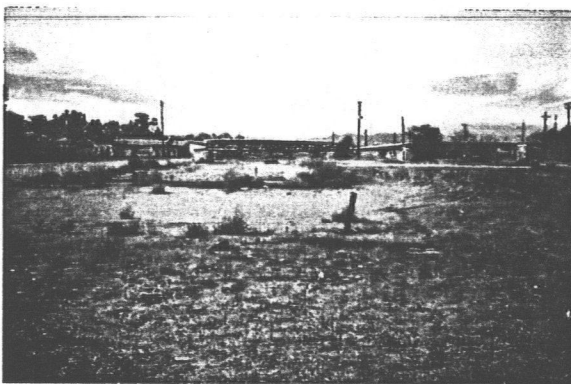
Vacant land with possible vehicle waste ramp and drain on southeast portion of the property.

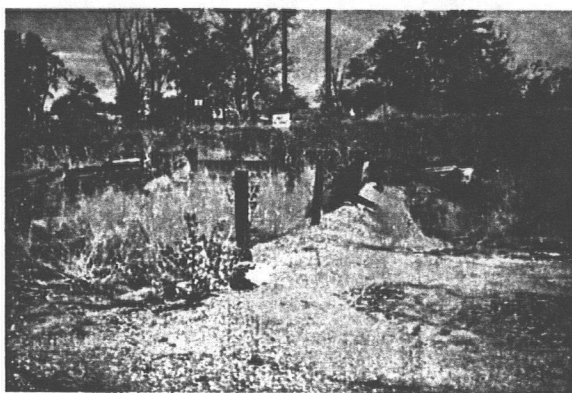
Storage bins for concrete aggregate on southeast portion of the property.
